RIKON #10-900 TOOL-LESS BLADE GUIDE SYSTEM RETROFIT KIT

INSTRUCTIONS ADDENDUM

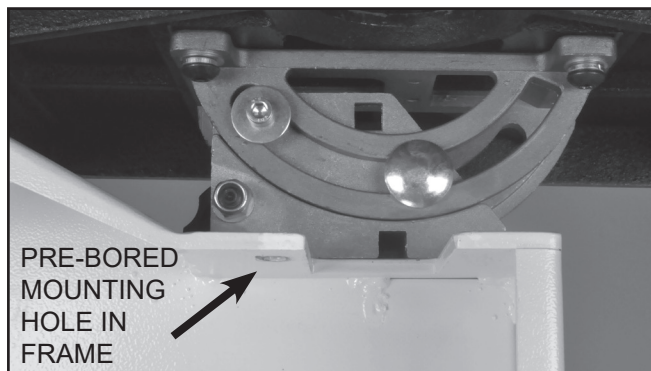
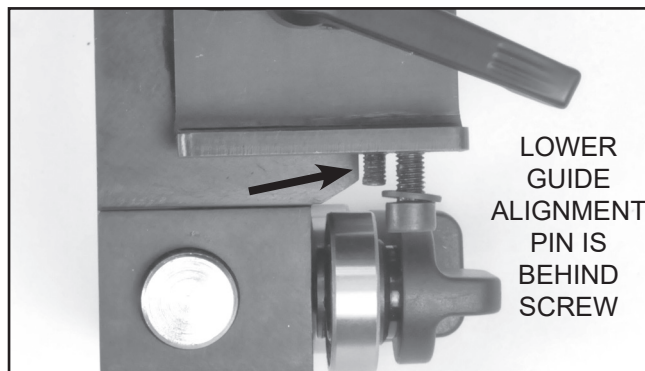
On older models of the 10-325 Bandsaws, the pre-bored mounting hole in the frame (Figure 4) may not be an oval shape to accept both connecting Hex Socket Cap Screw and Alignment Pin that are on the underside of the Retrofit Guide's Connecting Plate (Parts List #26). If this is the case, the new lower Tool-less Guides cannot be assembled onto the frame.

1. Remove the small Alignment Pin. This welded bolt can be sawn or ground off of the Connecting Plate. When removed, make sure that the bottom of the plate is smooth/flat where the pin was removed.
2. With a metal twist drill, rotary burr or file, enlarge the mounting hole to accept both the screw and pin. Make sure that any metal burrs from the drilling are removed from the frame.

NOTE: When installed, the new Tool-less Blade Guides and Guard should be positioned with the bandsaw blade centered in the assembly. See Instruction's Figure 5. If adjustments are needed, enlarging or widening the mounting hole in the frame (step 2 above) may be necessary.
